Technical features

VOLTA®

Prevention Maintenance – Cleaning – servicing – protection against frost

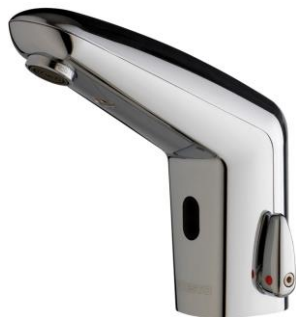
Flow Chart (3L/min model)

> **Flow rate**: controlled via an embedded flow limiter

> **Powered** either by

- 6 volts lithium battery (CRP2 type) placed in a casing within the tap body
- 230 Vac / 7 Vdc transformer within an IP65 casing

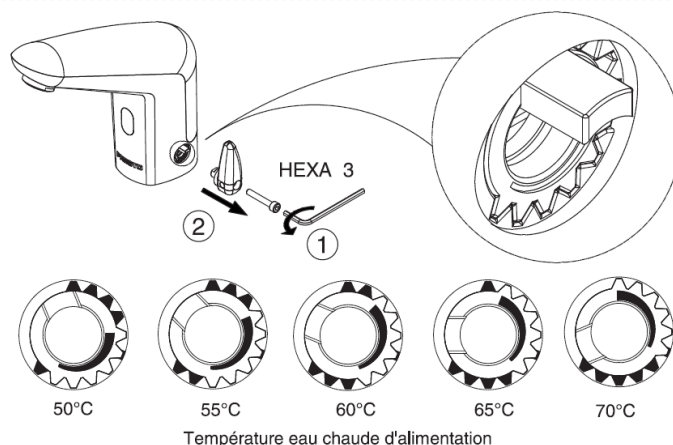
How to set up the mixer:

assuming a 15°C cold water and balanced pressure in order to
40°C water in max warm position put the toothed wheel
as per the pictures.

Mixer without lever : screw the mixer axis using a screw driver
Until you reach the expected temperature.
